UVC:

Florida Hospital Puts HVAC Maintenance Under A New Light

BY FIROUZ KEIKAVOUSI

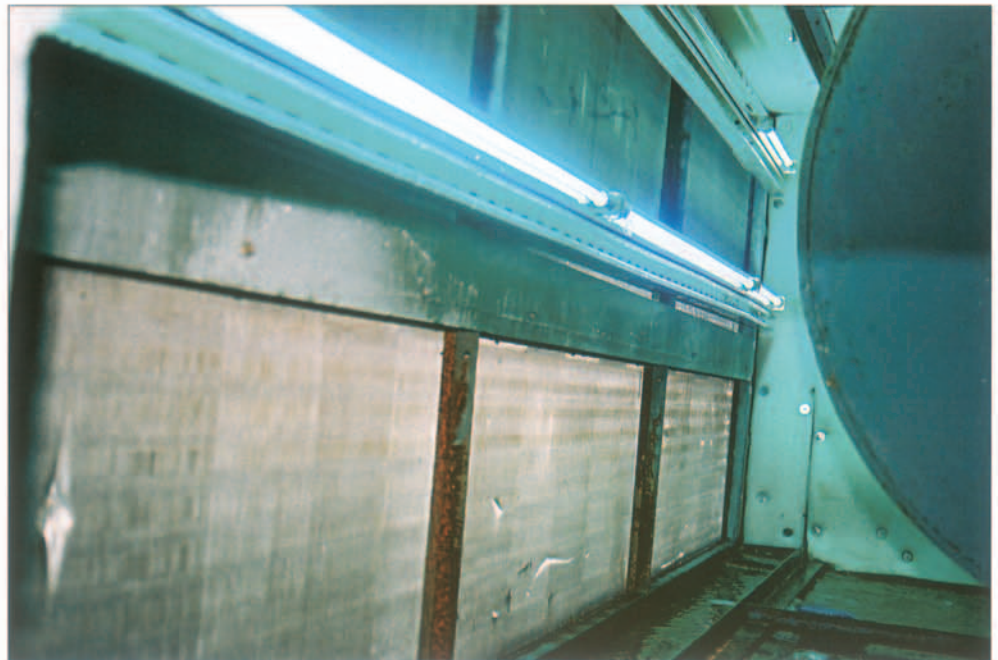
A recent UVC installation with a large coil.

After reviewing these initial results, the hospital administration agreed to expand the use of UVC. By the beginning of 2004, more than 100 AHUs in seven FH campuses were outfitted with the lights (Table 1), as well as some ceiling-mounted and portable air circulating units. To obtain desired results in the AHUs, we generally follow the manufacturer's recommended guideline of 24 in. of UVC tube length for every 4 sq ft of coil face area.
